SPACE SHUTTLE HOLDDOWN POST BLAST SHIELD

F. B. Larracas*

ABSTRACT

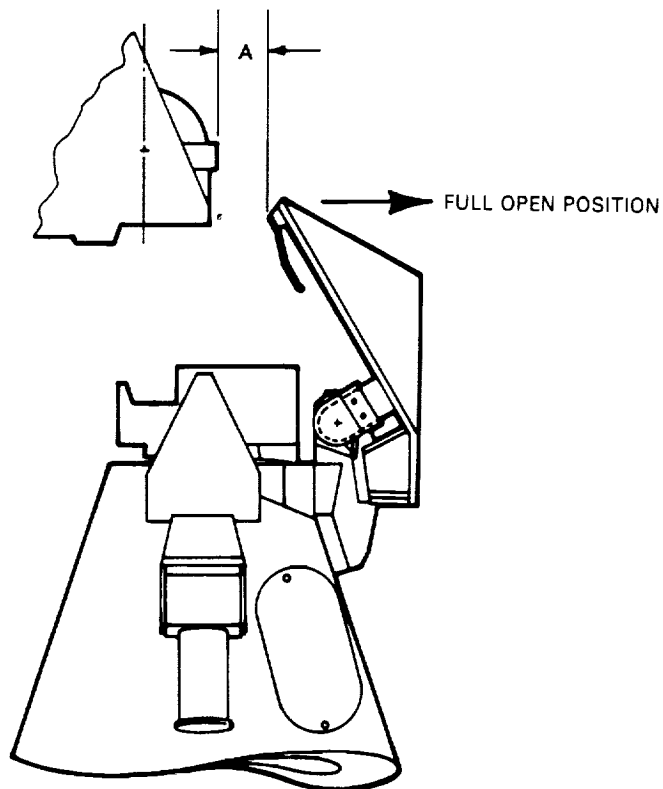
Figure 3. Blast Shield Modification and Installation

Accordingly, the blast shields were modified as follows (see figure 3):
